Progressive Mercury/040 Jumper Update: 3000T

Progressive Mercury/040 GAL Update: 030 Boot Conflict

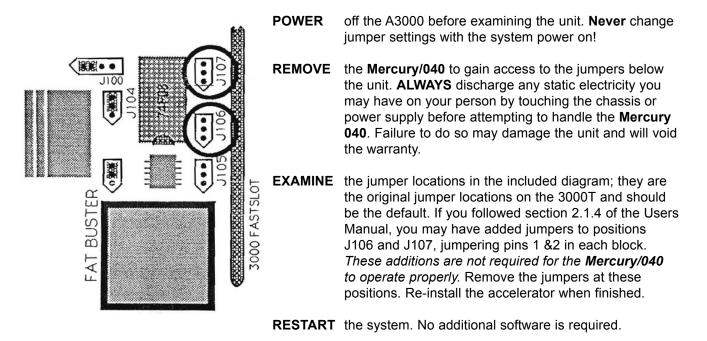
We have recently determined that the manual for the Progressive Mercury/040 is incorrect concerning the jumpering of the 3000T. Field testing has revealed that the board works perfectly without changing or adding any jumpers, despite section 2.1.4 in the Users Manual. While our jumper settings do not appear to change the performance of the system, we do recommend resetting the system's jumpers to avoid future conflicts. Please follow these procedures:

NOTE: Some users have taken to changing jumpers other than what we've suggested. This may change internal system timings that can lead to lockups, non-validated harddisks and floppies and complete systemwide failures. PP&S strongly suggests that you restore the jumpers to the default settings (as in the diagram) before serious data failure occurs.

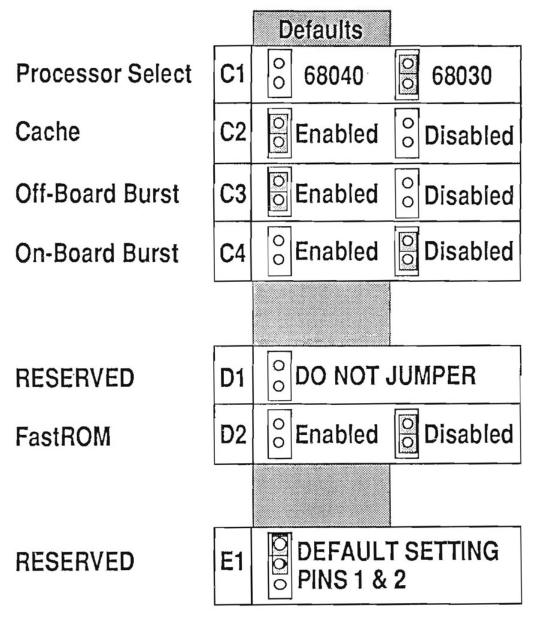
MERCURY SUPPLEMENTARY JUMPER SETTINGS

We have found that some early-release Progressive **Mercury/040** boards do not boot directly to the 68040, but rather to the native 68030 of the Amiga 3000's motherboard. This can happen on the first power-up or as a warm reboot. We have isolated this problem as being in a GAL chip on the **Mercury/040** in socket U301, and we recommend this chip change to alleviate the problem:

L	REMOVE	the chip gently using a chip removal tool, or a small flat-tip screwdriver.
CHIP U301 LATTICE GAL 22v10B-10LP		INSERT	the replacement Texas Instruments chip gently into the U301 socket, Take care that the notch in the chip orients to the left (as shown) and that the pins do not bend underneath the chip during installation.
]	INSTALL	in system as usual. The Mercury/040 will now always cold-boot into the 68040 mode, as expected. This will not affect the ability of Mercury/040 to switch between 040 and 030 modes.
		REPLACE	the original Lattice GAL chip in the protective foam block provided with the replacement GAL, and send it back to Progressive. This MUST be done to avoid being charged for the update.

After inserting the replacement GAL, the Progressive **Mercury/040** will operate normally under the Workbench 2.0 operating system. Please send the Lattice GAL to:
