Technical Notes on Expansion Peripherals:

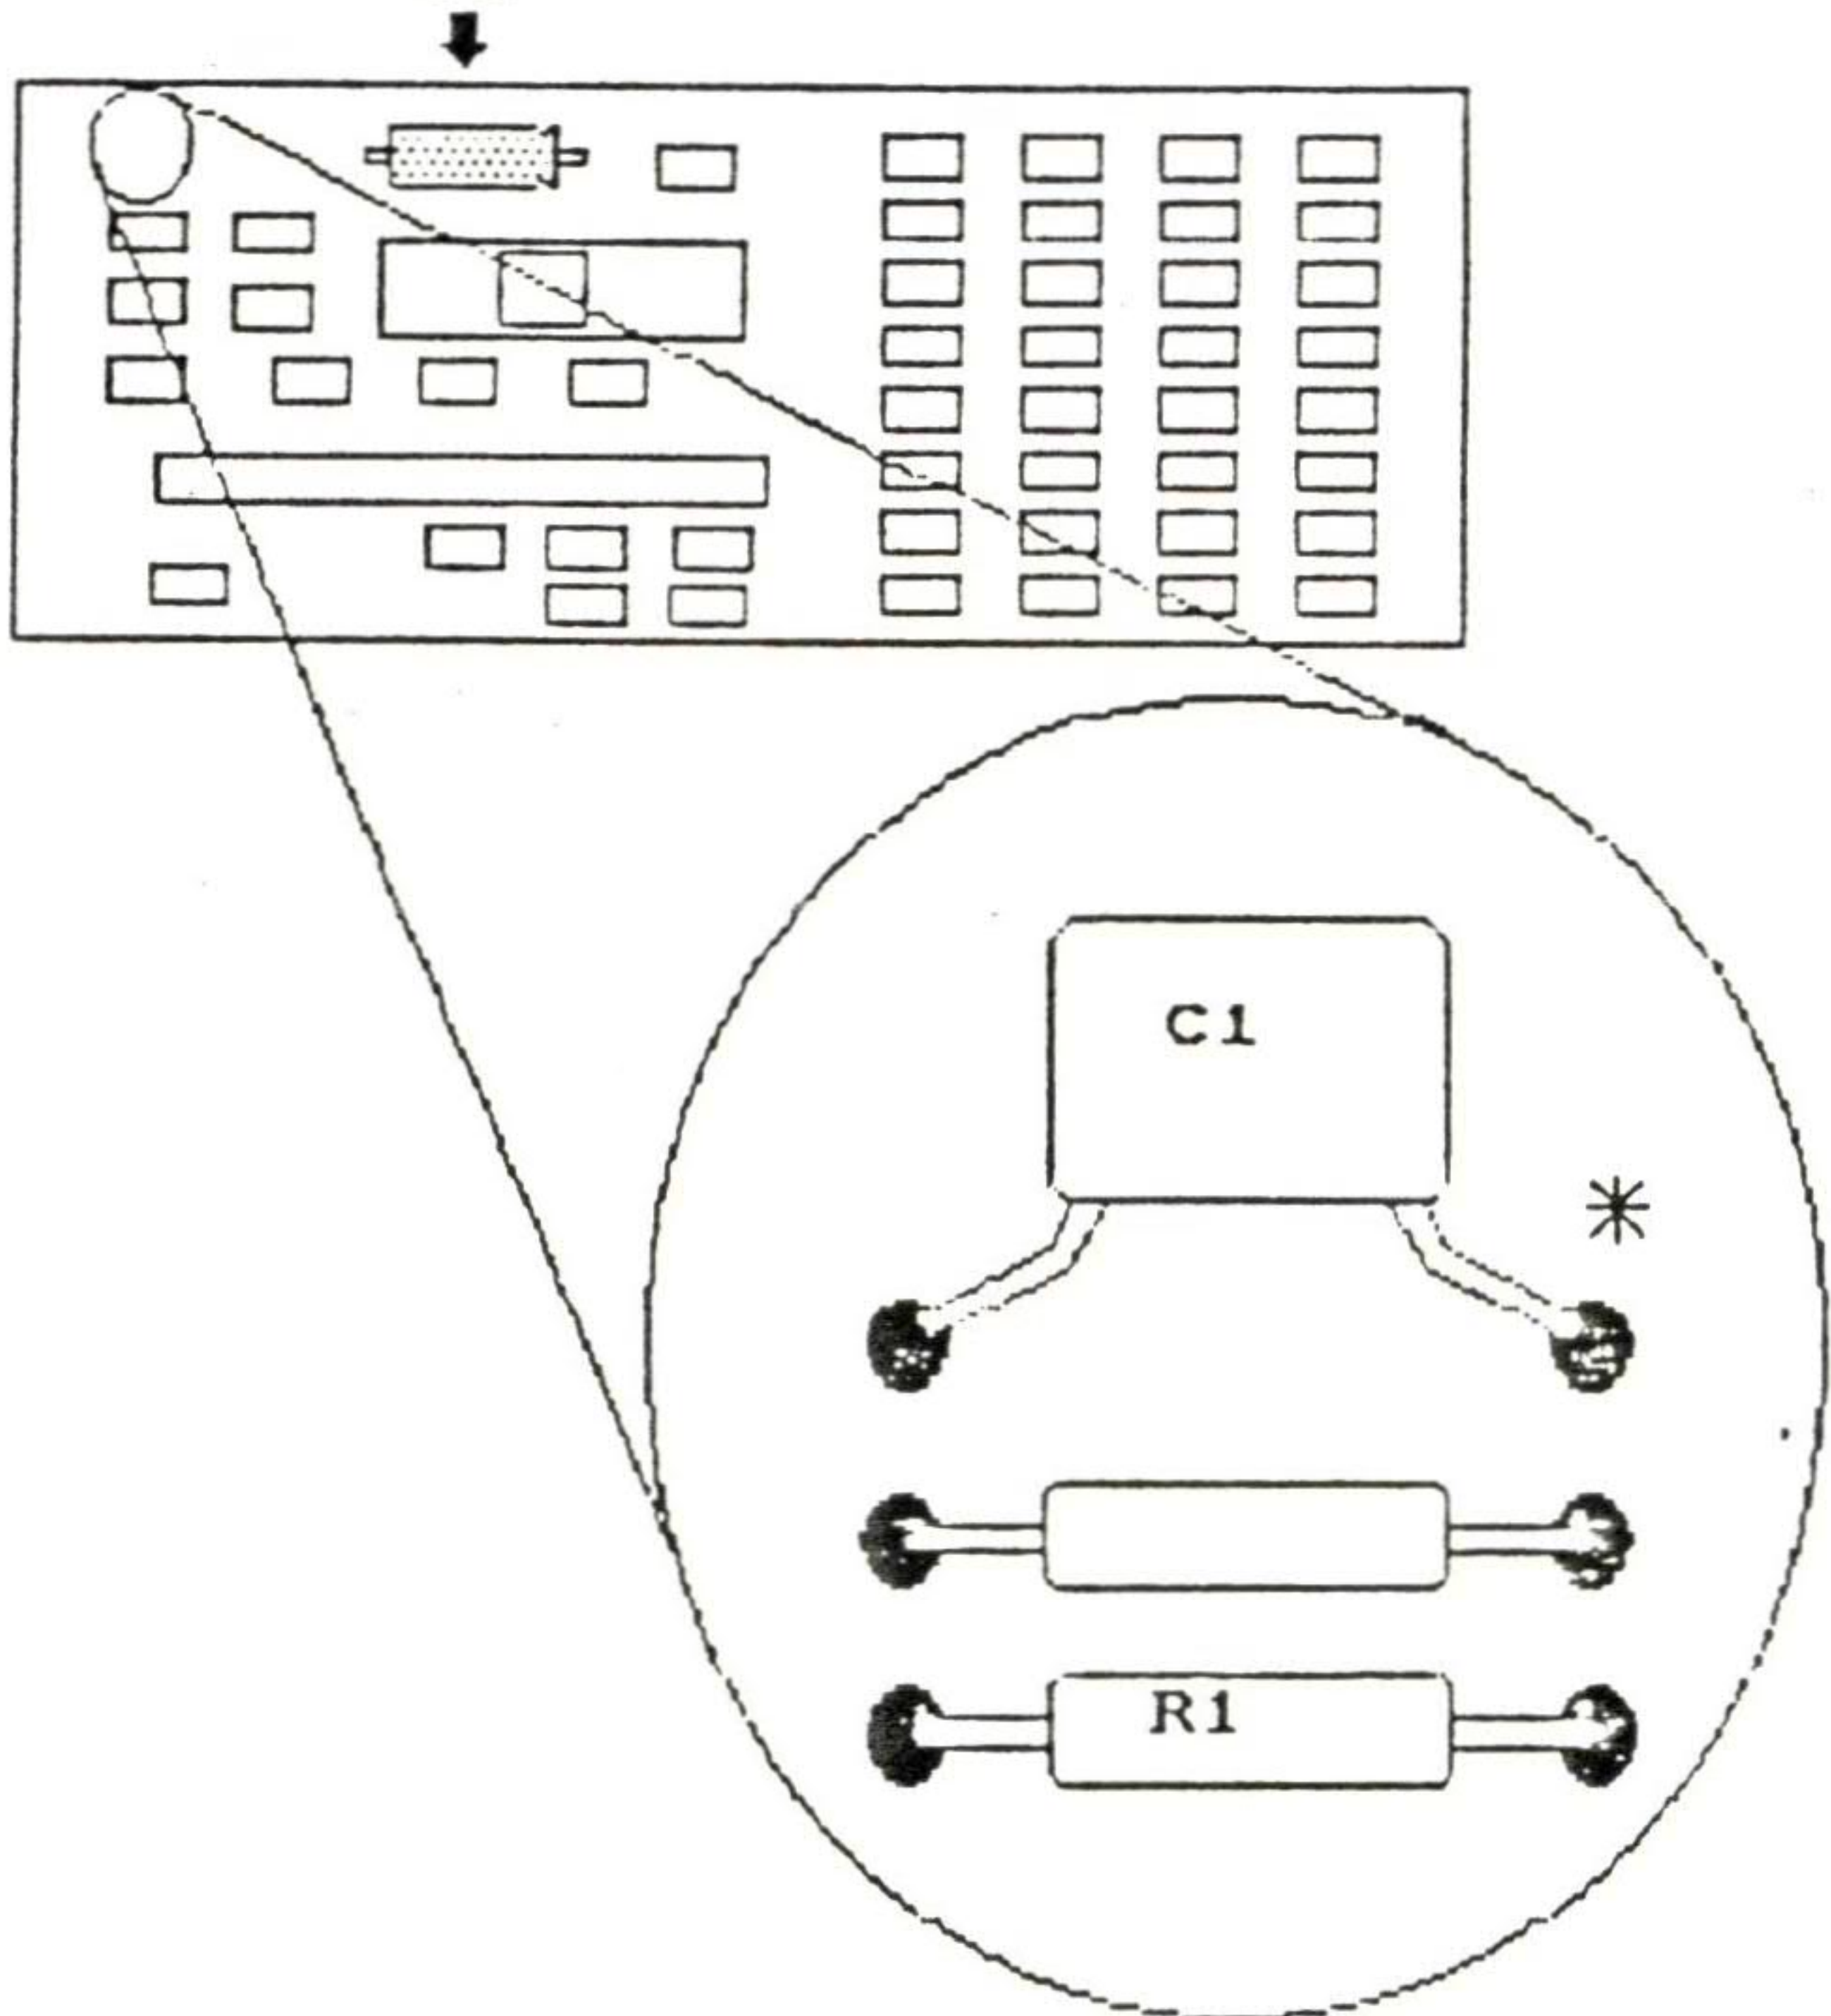
The only expansion port peripheral that we have found that doesn't function properly on modified Amiga's is C Ltd.'s aMEGA Card. However, the friendly folks at C Ltd. provided us with a simple fix that is described below: C2

Part	Old value	Recommended Change
R1	1K	100K
C1	0.01uF	0.47uF
C2	220uF	remove

* for the more adventurous, you can also try trying a diode between this side of C1 and Vcc (pin 14 of the adjacent 74LS00) with the "bar" on the diode connected to the Vcc side.
